## Let us speak about Corrosion

### What is corrosion?

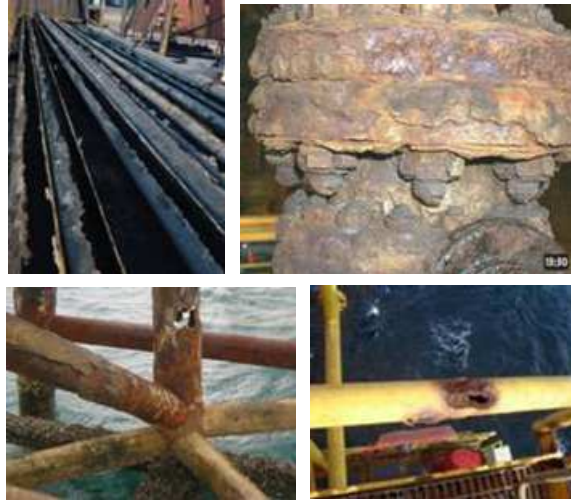
**Figure 2 – Corrosion of mature installations**  
 **tubing corroded by CO<sub>2</sub> - Surface valve - Corroded structure- Hole in a railing**

The most obvious effect of maturity when visiting mature installations is the corrosion of the surface installations. Both topsides (tanks, flowlines, railings, gratings) and jackets very often have a heavily corroded appearance as can be clearly observed in **Figure 2**. These corrosion problems are reinforced by sea level washing systems (sea water is a highly corrosive fluid). For jackets, both air and galvanic corrosion can play a role since the metal is alternatively immersed and emerged.

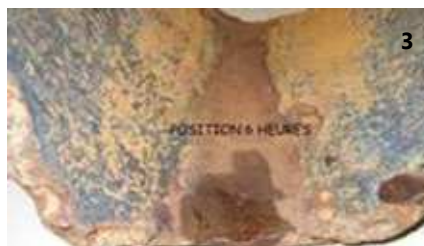
1. Subsea failure identification
2. Macroscopic longitudinal fracture
3. "6 hours" heavy reduction in thickness

**Figure 3 – Hole in a subsea oil production pipe converted into an injection pipe**

The example presented in **Figure 3** results in the conversion of an oil pipe into a water injection pipe without an initial coating. The rupture was observed following a total pressure drop in the injection system. The location of the damaged zone was identified using a ROV system (picture 1), then the damaged part was removed and temporarily replaced by a new section of safe pipe. The observation of the damaged zone after removal indicates a macroscopic longitudinal fracture 30 cm in length (picture 2) as well as a dramatic reduction in thickness (70% - picture 3 in the six o'clock position).
